Installation of four Piezometers at the Arbón Dam (Asturias)

Property:	Viesgo Generación, S.L.
Project:	D. Eduardo Ortega Gómez
Works Management:	D. Eduardo Ortega Gómez
Contractor:	Terratest Técnicas Especiales, S.A.

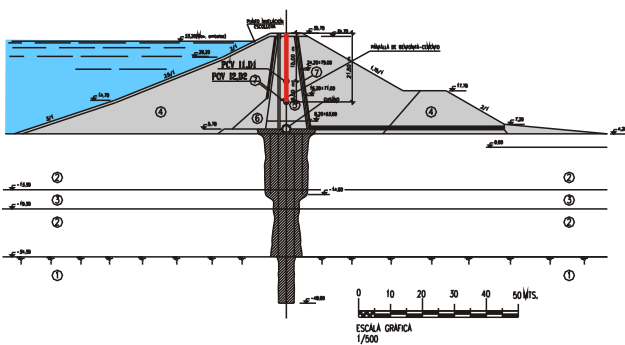
Vibrating wire piezometer

Auscultation of the Arbón Dam was reinforced by placing 4 vibrating wire piezometers in the abutments of the clay core.
